# How to dislodge or realign stuck volume dial/slider of an Arctis 7+

Written By: SevenPx

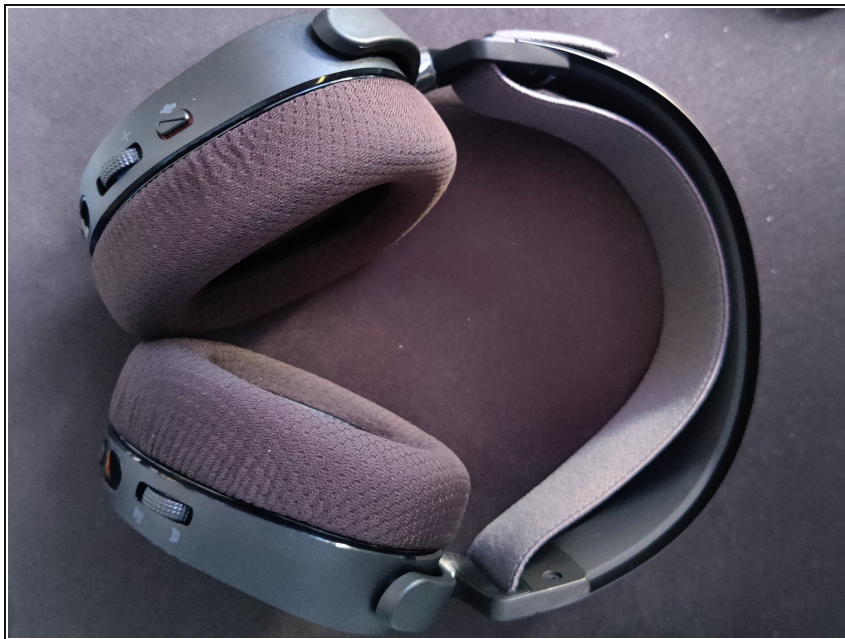
### Step 1 — How to dislodge or realign stuck volume dial/slider of an Arctis 7+

- First, identify the side you're removing the cups from. The volume side one is the left one with the hardware mute button, so this shouldn't be too hard.
