Razer Blade RZ09-0130 2015 Trackpad Button Replacement

Written By: Carson Kellerman

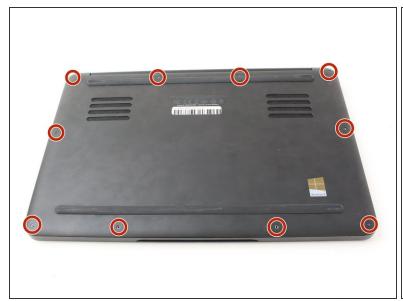
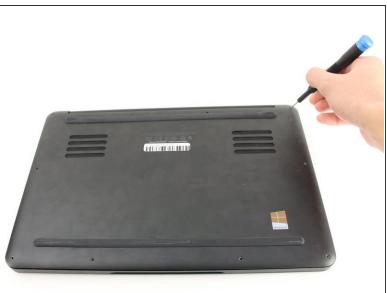
Step 1 — Back Panel

- Re sure to power off the device before beginning.
- Use a Torx T5 screwdriver to remove the ten 3 mm screws along the edge of the back panel.

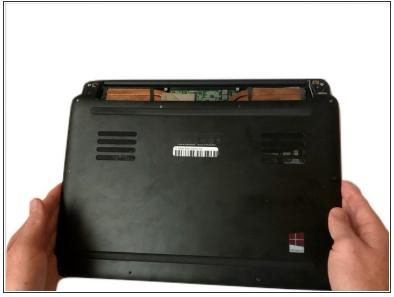
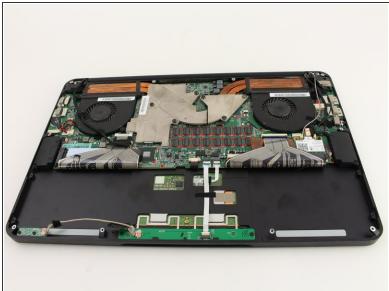
Step 2

- Remove the back panel from the laptop by sliding it away from the hinge.
 - This device is missing the battery. Make sure to detach the battery connector before proceeding with laptop repairs.

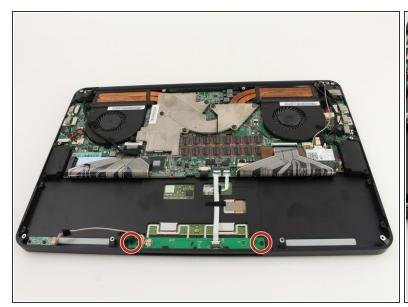
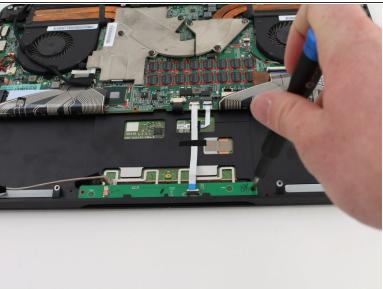
Step 4

Use a Phillips #1 screwdriver to remove the two 3 mm screws holding the trackpad's circuit board to the chassis.

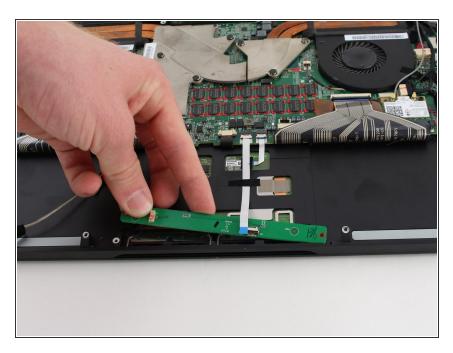
Step 5

Remove the trackpad circuit board by holding one end and gently lifting it upwards.
