# Philips Sonicare FlexCare UV Light Bulb Replacement

The UV light bulb in the sanitizer will be replaced.

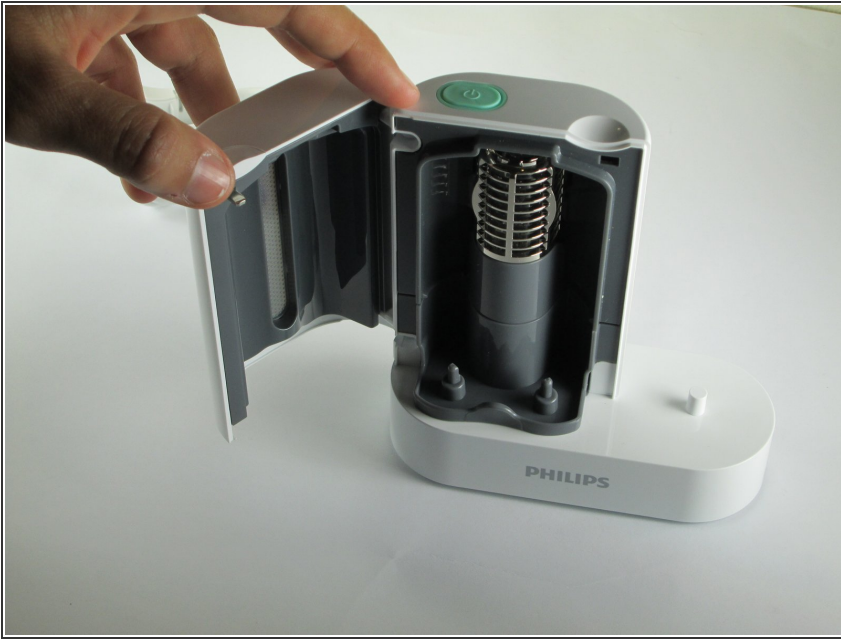
## Step 1 — UV Light Bulb

- Before initiating the process, ensure that the sanitizer is not plugged into an outlet. Swing the door open to expose the interior of the sanitizing device.

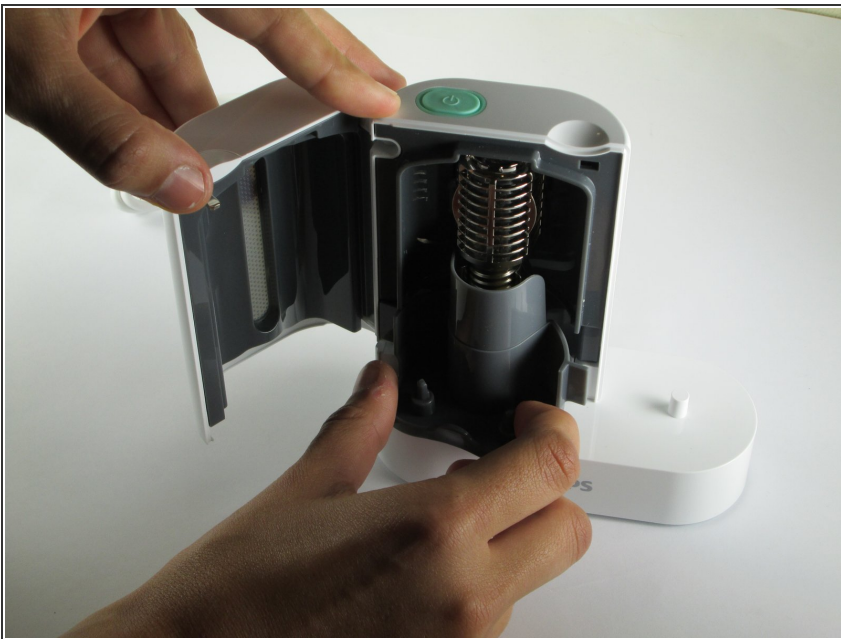
## Step 2

- Grip the sides of the plastic cover that is shielding the circuitry. Pull the cover outward to remove it from the sanitizer.

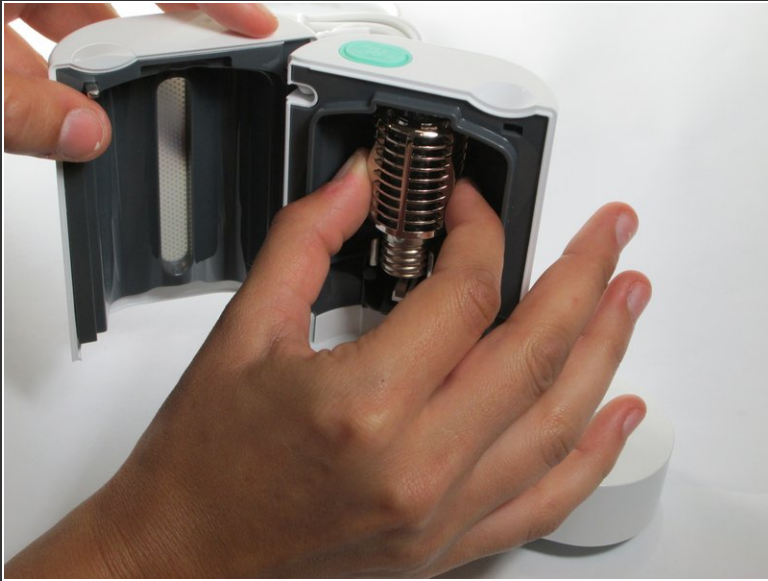
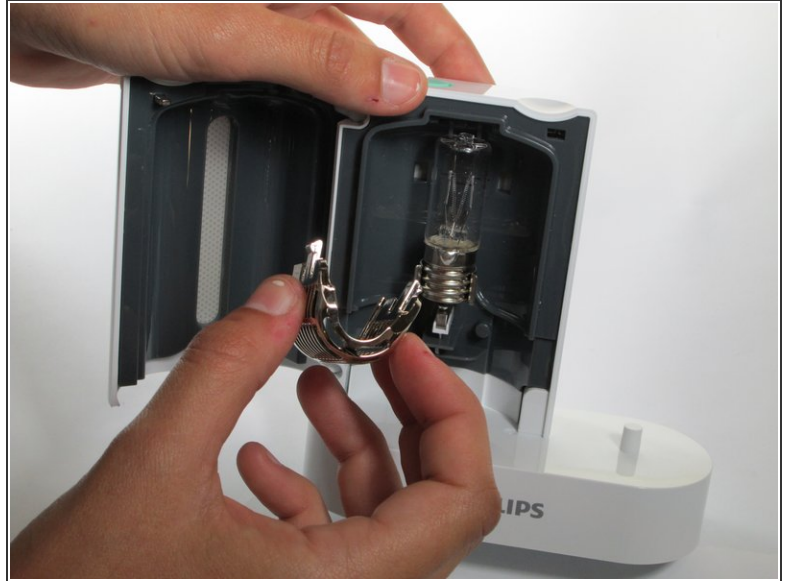
### Step 3

- Squeeze the sides of the guard that is placed over the UV light bulb. Pull the piece outward to remove it.

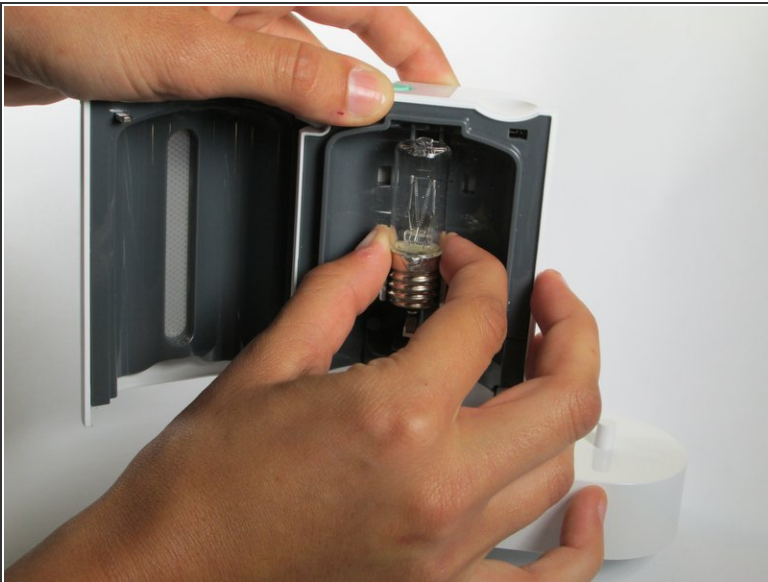
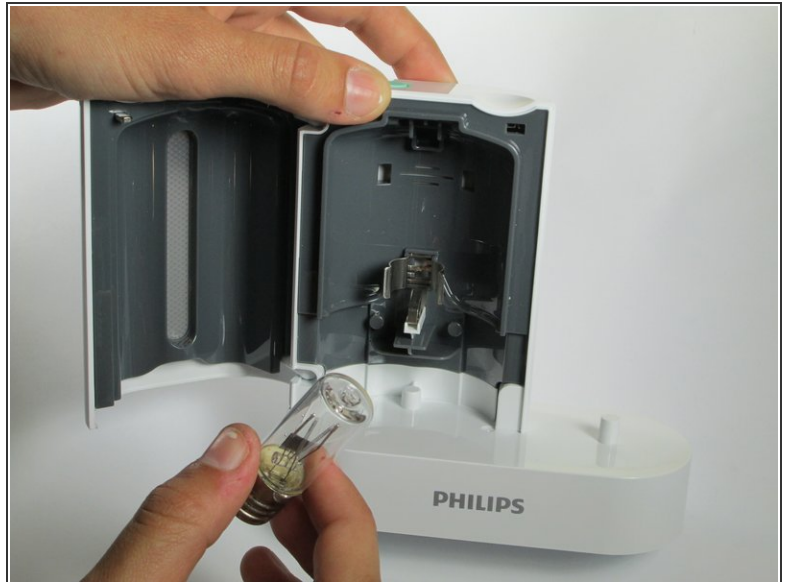
### Step 4

- Before holding the light bulb, ensure that it is not warm due to previous use. Once that is confirmed, take a hold of the light bulb by the threaded surface and rotate it while pulling it outward. Have a compatible UV bulb to replace the old one.
