Fujifilm Instax Mini 8 Infrared Blaster Replacement

This guide helps you recognize the steps to fix your IR blaster on an Instax Mini 8.

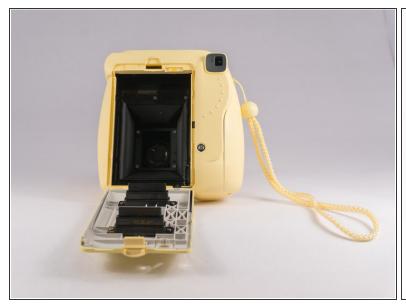
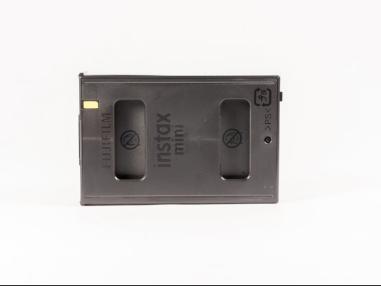
Step 2

Open the rear compartment and remove the film cartridge.
