# 2017 Kia Niro Headlight Replacement

This is a guide for replacing a broken or faulty 2007 Kia Niro headlight.

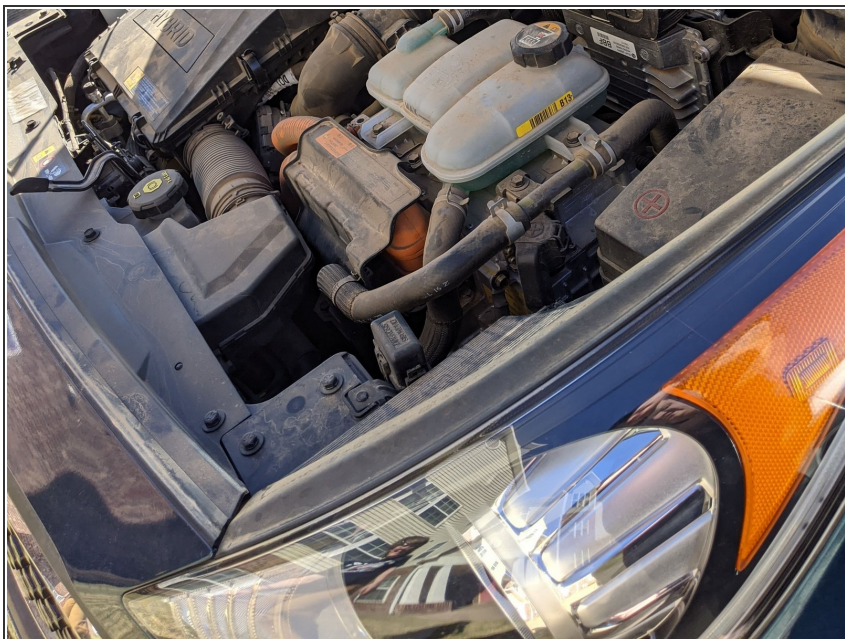
## Step 1 — Headlight

- Open the hood of the vehicle and make sure it is secured to prevent injury.

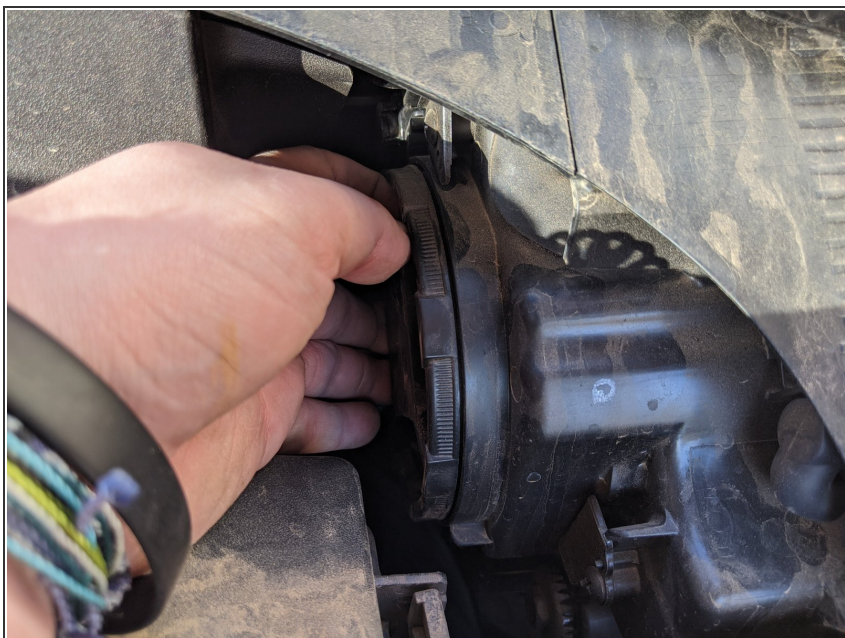
## Step 2

- Locate the bulb cover cap which can be found under the hood and directly behind the headlight.

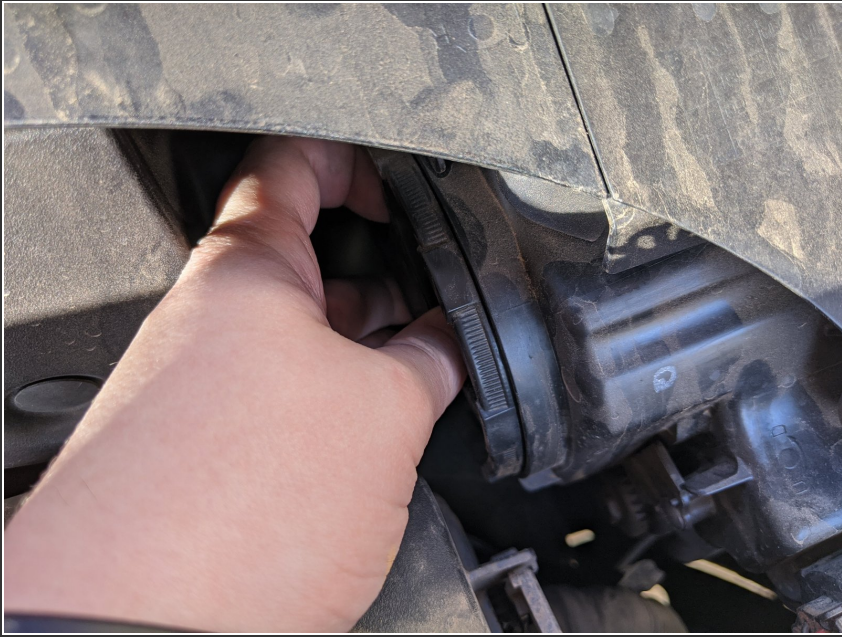
### Step 3

- Remove the bulb cover cap by rotating it counter-clockwise until it is fully detached.

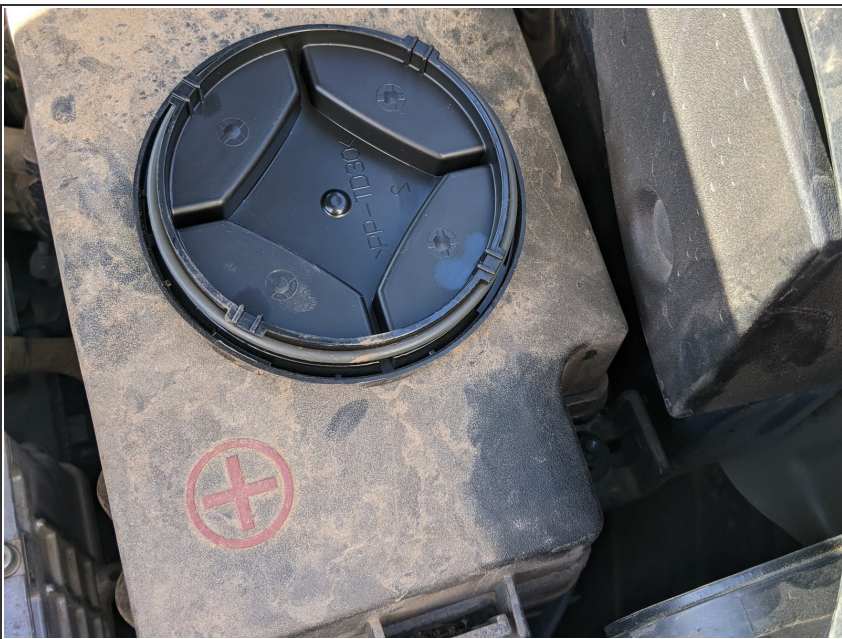
### Step 4

- Place the cap in a location that is out of the way of your work area and where you can easily find it.

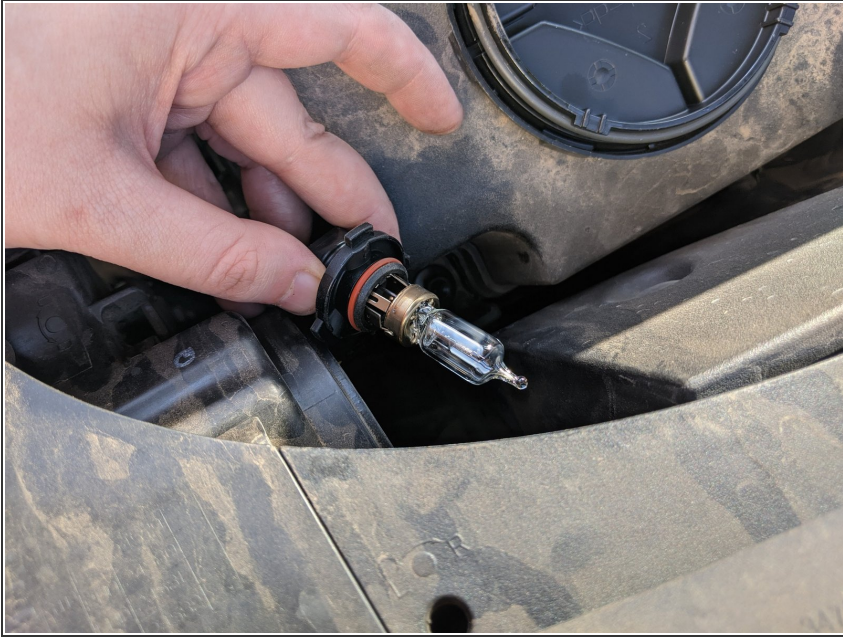
## Step 5

- Remove the old bulb by rotating counter-clockwise until it is detached, being careful not to drop the bulb into the hood of the vehicle.

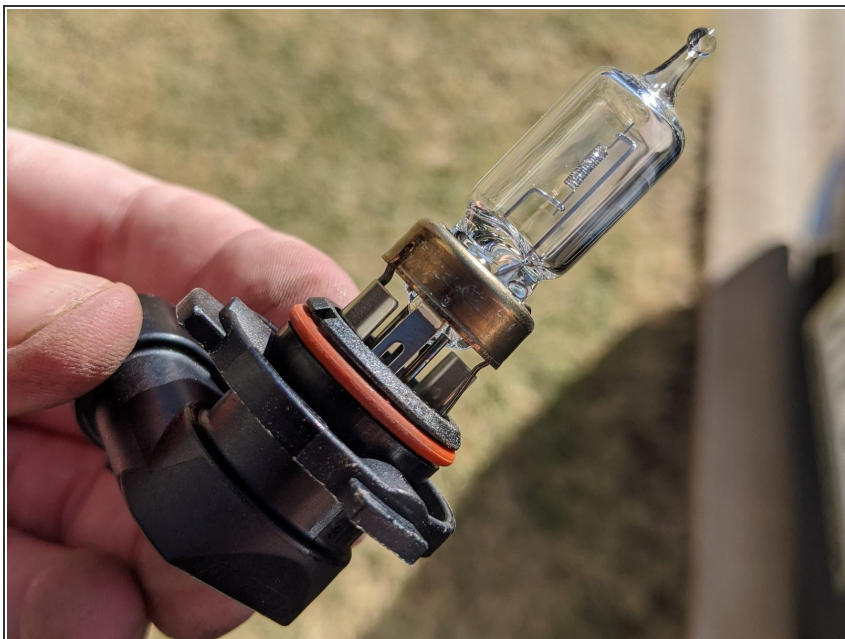
## Step 6

- Prepare your replacement XtraVision Fog Light/Headlight Bulb 9005XV-2 for installation by removing it from the packaging and ensuring that the bulb is not broken.

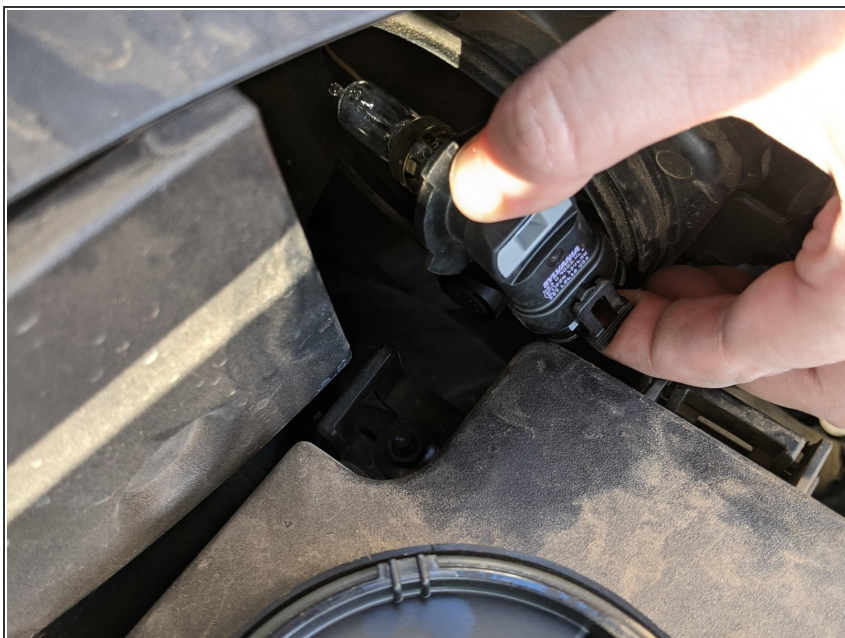
## Step 7

- Insert the new bulb by pushing it into the bulb compartment.
- Turn the bulb clockwise until it is secure.

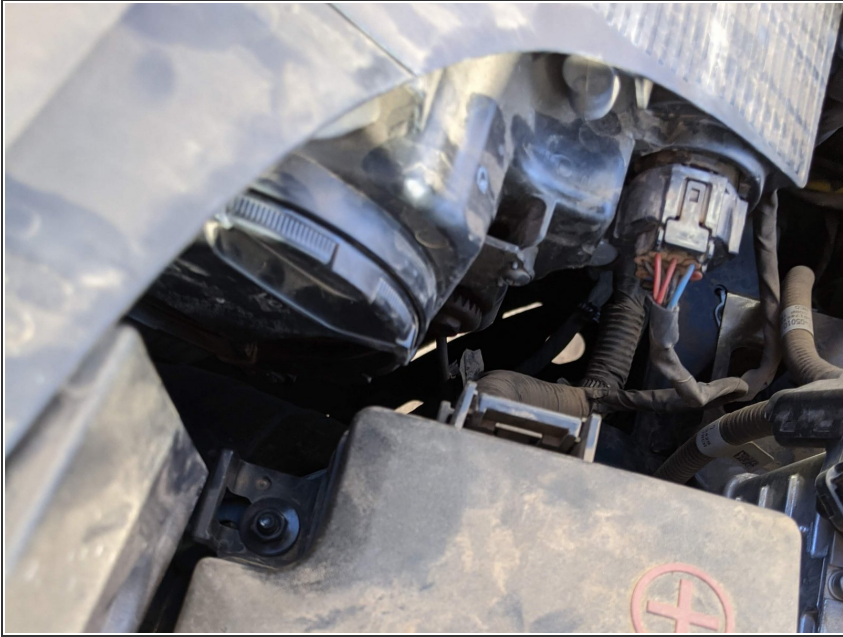
## Step 8

- Reattach the cap you previously set aside by rotating clockwise until secure.
