HTC One M9 Teardown

Teardown of the HTC One M9 on April 2, 2015.

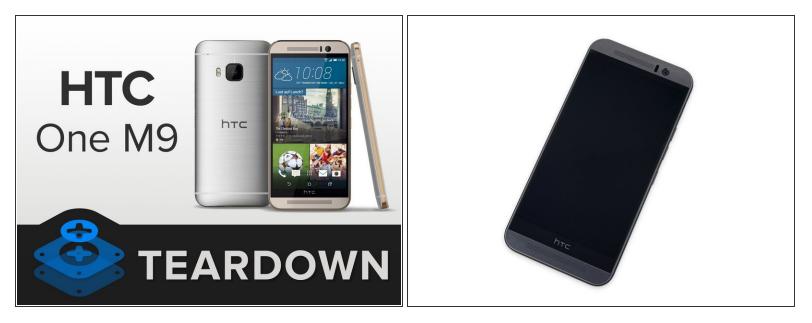
Step 1 — HTC One M9 Teardown

- HTC hopes the M9 will be the *One* for you. Let's see just what it's packing:
 - 5.0-inch, 1920 x 1080 display, with front-facing stereo speakers
 - 20 MP rear-facing camera with 4K video recording; HTC UltraPixel front-facing camera with 1080p video recording
 - Qualcomm Snapdragon 810—64-bit, octa-core (4 x 2.0 GHz + 4 x 1.5 GHz)
 - 3 GB RAM
 - 32 GB of on-board storage; up to 2 TB additional microSD storage
 - LTE, Bluetooth 4.1, NFC, HDMI MHL 3.0, 802.11ac, and IR blaster

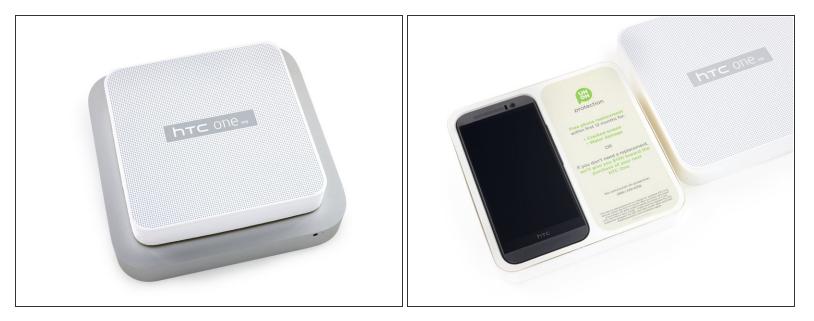
- Did HTC secretly send us a Mac Mini? No, but it's definitely a uniquely designed box.
- HTC recently rolled out <u>"Uh-Oh Protection"</u> for One M8 and One M9, promising an entire replacement phone for a cracked screen or water damage in the first year of One-rship.
 - (i) We're betting this deal has something to do with the <u>repair-unfriendly design</u> that these phones share.

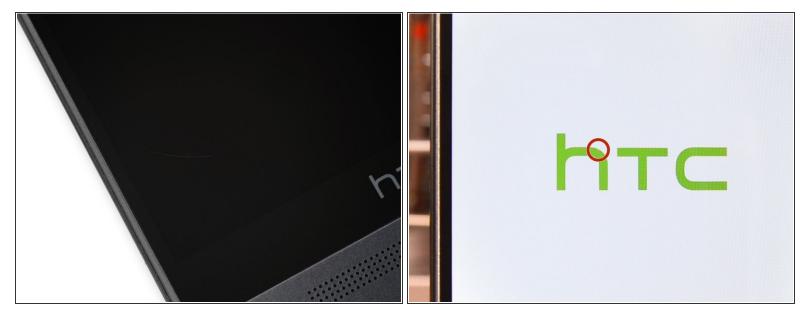
- HTC has been experiencing some <u>shipping delays</u> with the One M9, presumably due to a lack of stock.
 - Coincidentally, our phone seems to have encountered more relaxed quality standards than is expected from HTC.
- Straight out of the box we noticed a large scratch on the bottom left corner of the display glass.
- And it doesn't stop there! When we first booted up the phone, we were greeted by a lovely defective pixel near the middle of the screen.
- (i) These issues are giving us a <u>bad feeling about this</u> phone...

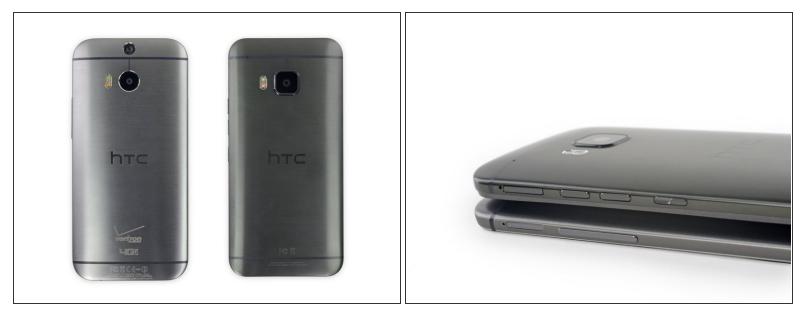
- The dual-tone metal unibody of the M9 is practically identical to that of the M8. The gunmetal gray M9 is just a shade darker than its older sibling; otherwise, you might say these HTCs are twins! Well, almost...
- The M9's most noticeable difference from its <u>predecessor</u> is a return to a single rear camera, like the original <u>HTC One</u>. Possibly HTC decided that competing with the <u>3DS dual camera</u> was a little beneath them.
- The M9's secondary metamorphosis was a migrational button shuffle.
 - With the iPhone 6 and 6 Plus, Apple learned that a top-mounted power button doesn't cut it for a hand-stretching phablet, and <u>moved its power switch to the side</u>. Looks like HTC caught on and followed suit with the M9.
 - The M9 also replaces the rocker switch of yesteryear with dedicated volume +/- buttons.

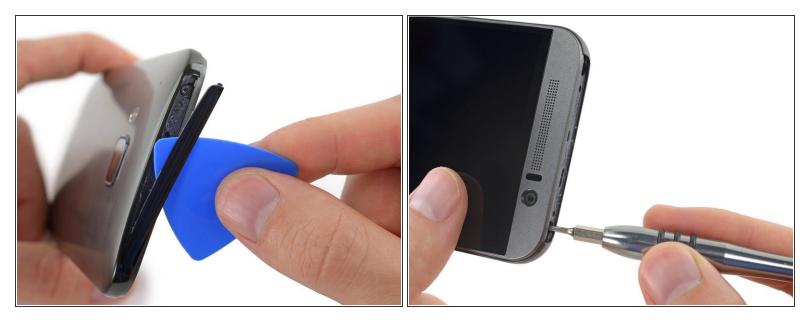
- Some persistent <u>picking</u> at the top of the case reveals a couple of Torx screws.
 - Gone are the frontal access panels. The two screws at the top are all the M9 relies on, so far at least.

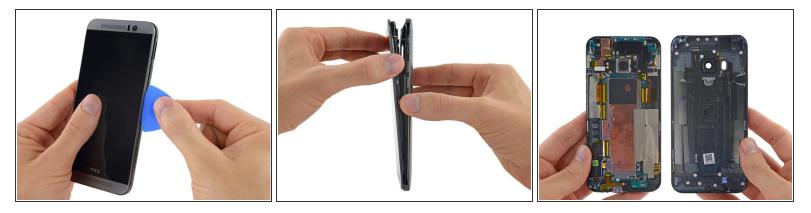
- Unlike the original HTC One, there's no need to Heat The Case of the M9. After removing the top panel's screws, we get straight to business with an opening pick to Handle Those Clips.
- We use our trusty pick to rent the phone in twain carefully separate the rear case from the body of the phone.
- The bottom clips are particularly stubborn, but so far, no adhesive!
- As we pop the rear case of the M9, we get our first view of the tender morsels inside. At first glance, this new HTC One closely resembles the M8.

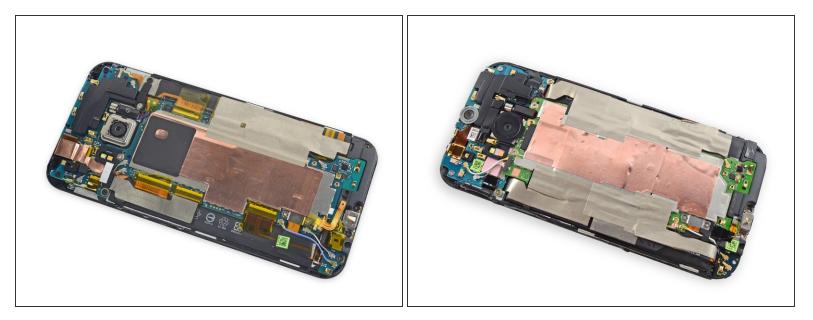
- HTC clearly loves its shielding. We're thankful that they've abandoned the tape strata of the M8 (second image), for a slightly cleaner and more accessible design on the new M9 (first).
- Aside from the minor housekeeping and ditching the Duo Lens depth-perceiving camera, not much seems to have changed.
 - (i) Except for the color. The motherboard is now blue, which probably makes it run faster than last year's green.

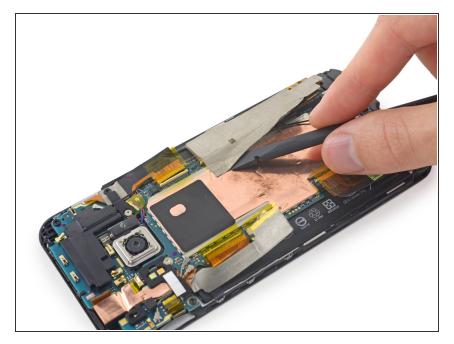
- This HTC teardown is feeling a lot less like the <u>open heart surgery</u> we had to perform on the M8.
- Whoever went tape-happy last year has been duly pacified. While there are still plenty of connectors, they're easier to get to, and to dispatch.
- (i) Let's hope we don't jinx this motherboard removal...

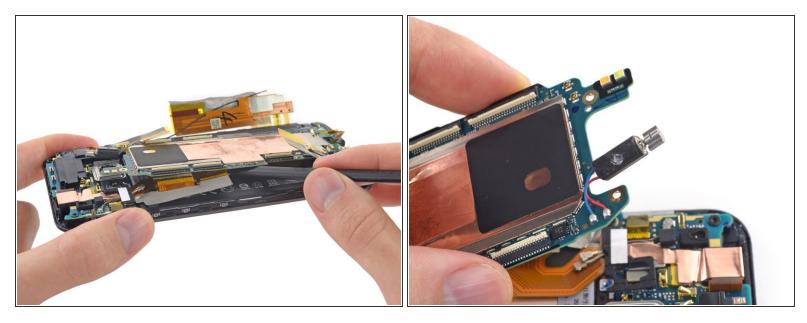
Augh! What is this? Looks like HTC's engineers weren't interested in our input from the M8. They've stuck with their habit of <u>gluing down the motherboard</u>.

Not only is the motherboard adhered, it's bang up against the battery—a "soft" battery.

- After some very gentle prying with a blunt spudger, we manage to free the motherboard and not catch fire.
 - Phew!
- Oh and the rotational vibrator? Yeah, it's now soldered to the motherboard, and (lightly) adhered to the case.

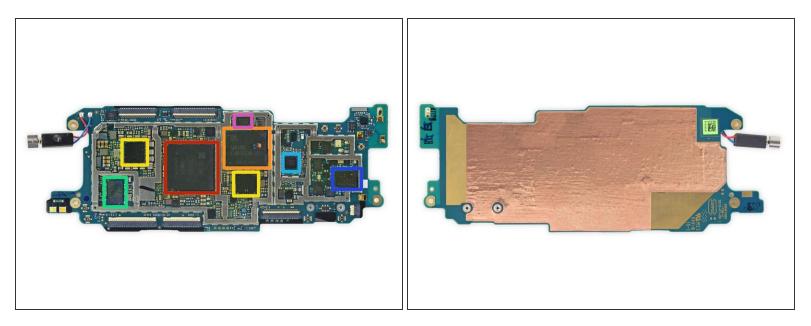
- Here're The Chips! Covered in what hopefully isn't snot (they came a little dirtier than we're <u>used</u> <u>to...</u>)
 - Samsung <u>K3RG3G30MM-MGCH</u> 3 GB LPDDR4 RAM + Qualcomm <u>Snapdragon 810</u> octa-core CPU
 - Samsung <u>KLMBG4GEND-B031</u> 32 GB eMMC NAND flash
 - Qualcomm PMI8994 Power Management IC
 - Broadcom <u>BCM4356</u> 2x2 802.11ac Wi-Fi solution with Bluetooth 4.1 support (Also found in the <u>Nexus 6</u>)
 - Qualcomm <u>WTR3925</u> 28 nm RF transceiver
 - Avago ACPM-7800 multimode, multiband power amplifier module
 - Silicon Image <u>SIL8620</u> MHL 3.0 transmitter

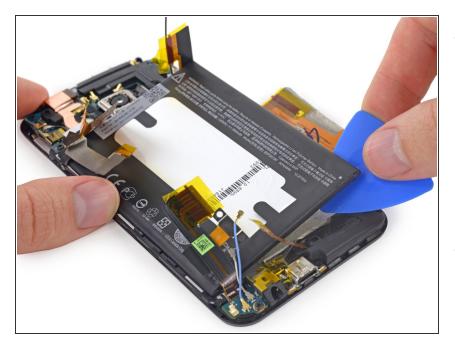
- Now that the motherboard is out, we can remove the (hopefully undamaged) battery! After some more prying, that is.
 - Yep, the motherboard <u>still</u> has to come out before the battery. And the battery is *still* a glue sandwich —Hold The Cheese.
- We complained <u>last year</u>, and we Have To Complain again this year. A lithium-ion battery is a consumable —it's only good for a <u>limited number</u> of charge cycles before it starts to lose capacity and needs to be replaced.
 - Burying the battery so deeply within the device signs its death certificate the day of its manufacturing birth.

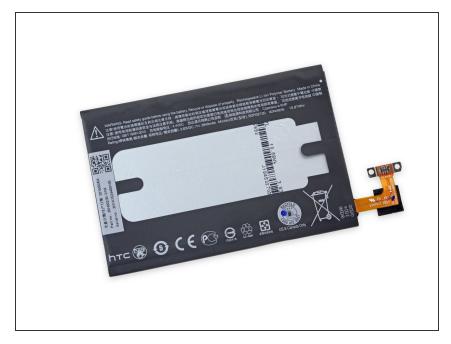
- Spec-wise, HTC has once again given the battery a slight capacity boost—up to 10.87 Whr from <u>yesteryear's</u> 9.88, but still a little shy of the 11.1 Wh in the <u>iPhone 6 Plus</u>. (The original One sported a measly 8.74 Whr battery.)
 - AnandTech's review found the M9's battery life slightly disappointing compared to the M8. It seems HTC made an effort to stop the bleeding with a capacity bump, but it's ultimately not enough to surpass its predecessor.
 - Add the fact that the M9 supports <u>Qualcomm's new Quick Charge</u> <u>2.0</u> spec, but ships with a conventional 5 V, 1.5 A charger that can't provide the quick juice, and we're a little disappointed.
 - (i) Take note, HTC. The <u>Nexus 6</u> accepts Quick Charge *and* ships with a quick-charge compatible charger.

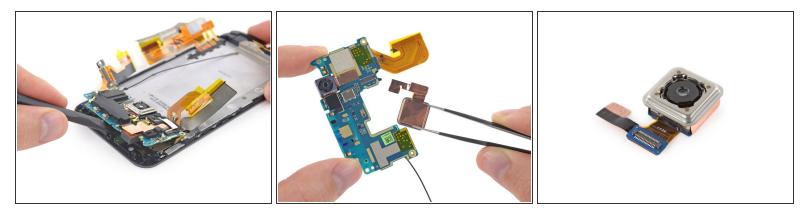
- We want to get a look at the M9's <u>Highly Touted Camera</u>. After one last connector, a few more screws, *and* some adhesive, the daughterboard is finally free.
- And with it, the newly single rear-facing camera.
 - (i) You go, camera—you are a strong independent image capturing component that doesn't need any gimmicky 3D to define you.
- The M9's 20 MP rear camera sports a sapphire cover lens—possibly in response to <u>criticism</u> of an easily-scratched cover on the M8. HTC seemingly took a cue from <u>Apple</u> and introduced some camera bling.

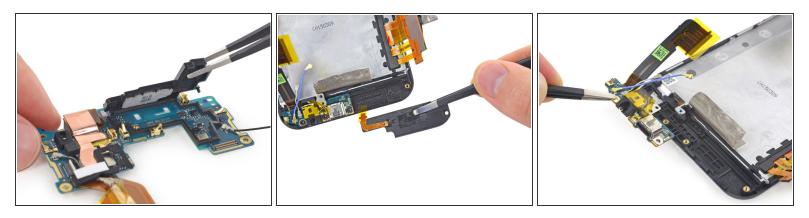
- Speaker box! Full of styrofoam! Such technology.
- HTC's BoomSound speakers make their encore performance in the M9. This new iteration of the BoomSound speakers sports Dolby Audio, bringing a full soundstage to your video chats with Nana.
- We tweeze out the I/O board, along with the attached 3.5 mm audio jack, microphone, and micro-USB port.

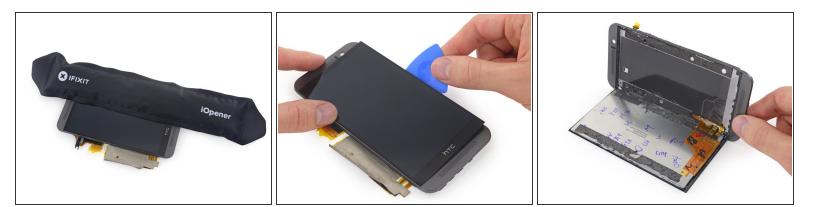
Step 15

- It's time to turn up the heat! Two particularly sticky strips of adhesive stood in our way, and it took a lot of careful heating and prying with the <u>iOpener</u> to free the LCD.
- We find numerous cryptic characters scrawled on the back of the LCD. Does this One have a secret message for us?
 - (i) After consulting our <u>Highly Trained Cryptologist</u>, we've been informed that they're probably just quality assurance marks.

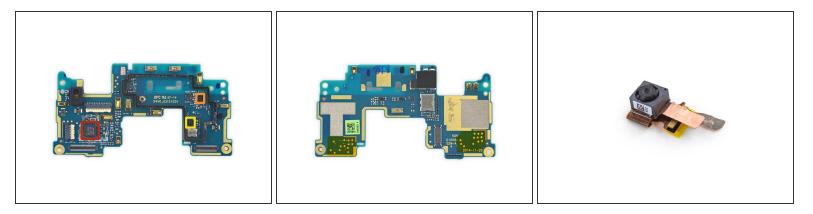
- The camera board is out of the phone and ready for its close-up. Here's what's chilling on the board:
 - NXP <u>47803</u> NFC controller, as seen in the <u>Amazon Fire Phone</u>
 - Qualcomm <u>QFE2550</u> antenna tuner
 - Maxim Integrated MAXQ614 16-bit microcontroller with infrared module
- It looks like HTC moved all their <u>Ultrapixels</u> to the display side—this 4 MP front-facing camera has the same specs as the M8's primary camera, but in a slightly smaller package.

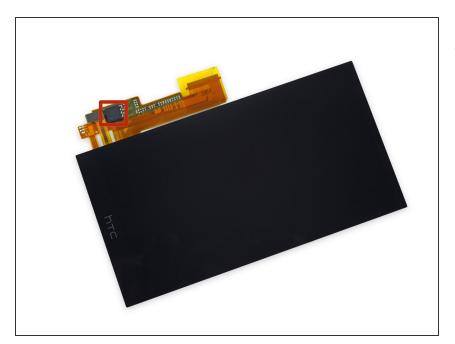
Step 17

- Mounted to the display assembly ribbon cable, we see the Synaptics S3351B touchscreen controller.
- (i) This is likely an iteration of the S3350B found in the <u>Nexus 5</u>.

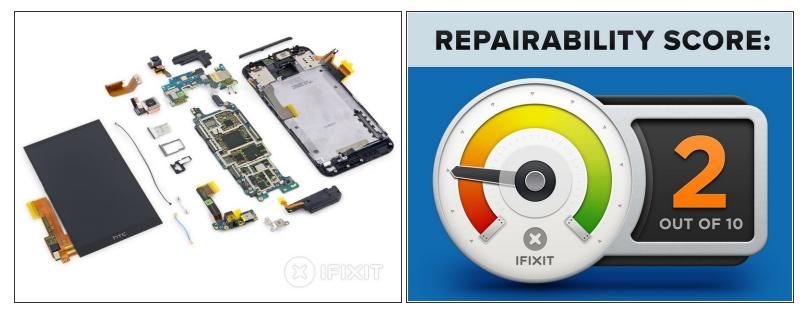
- HTC One M9 Repairability Score: 2 out of 10 (10 is easiest to repair)
 - The battery is buried beneath the motherboard and adhered to the midframe, hindering its replacement.
 - The display assembly cannot be replaced without tunneling through the entire phone. This makes one of most common repairs—a damaged screen—very difficult to accomplish.
 - Intense adhesives make many components difficult, and even dangerous, to remove and replace.
 - HTC thought they could Have Their Cake and eat it too, by making a flagship phone that's tough to repair. Sorry HTC, but this design Has To Change.
 - Design streamlining (upper access panel and reduced tape/shielding) makes for slightly easier access to some components.
